Manhole Inspection Summary

Manhole # S55A__007MH

Insp Date: **6/24/08 9:42 AM**

Location Address: **rear 3638 e fayette st**

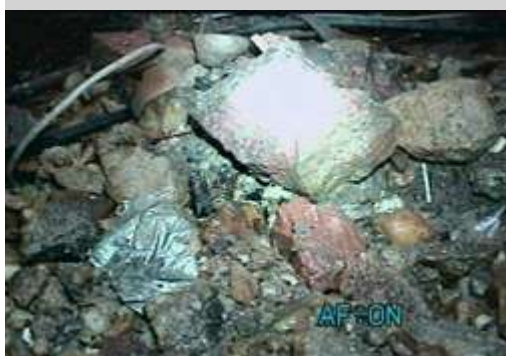
Defect 3

Condition: ☐ Sound ☐ Cracked ☐ Root Intrusion ☐ Deteriorated ☐ Leaks ☒ **Debris**

channel debris

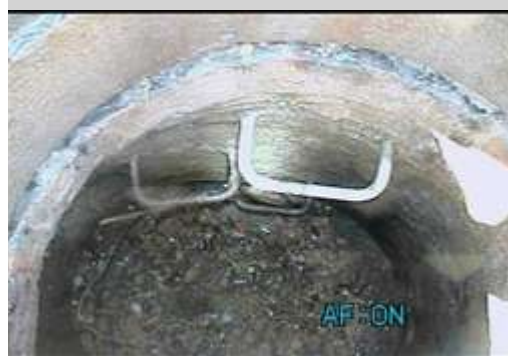
Defect 2

Steps Count: **3** Missing: **0** ☒ **Corroded**

steps

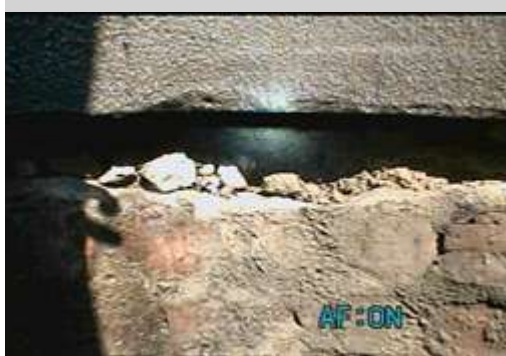
Defect 1

Condition: ☐ Sound ☒ **Cracked** ☐ Root Intrusion ☐ Loose Brick ☒ **Deteriorated**

Chimney cracked,
deteriorated frame adj

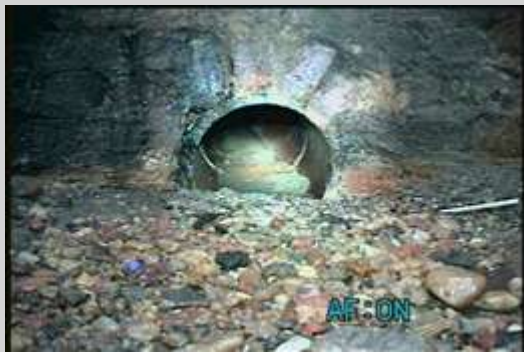
12 O'Clock Outflow

8 in. Circular Gravity Sewer
Pipe Out @ 12 O'Clock

Pipe Material: **Clay** ☐ Pipe Lined

Invert Depth: **6.90** (ft.) Flow Characteristics: **None**

Deposits: ☒ None ☐ Mud ☐ Sludge ☐ Debris ☐ Grease

Infiltration: **None** Pipe Seal Cond: **Unknown**
